**Report No. CDOT-2007-3  
Final Report**

# **DURAFLEX CURB**

**COLORADO DEPARTMENT OF TRANSPORTATION  
RESEARCH BRANCH**

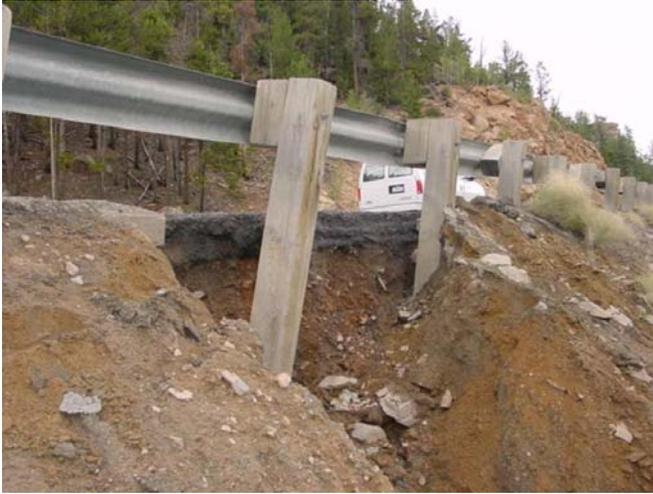
**Figure 1. Dangerous erosion on US-50.**

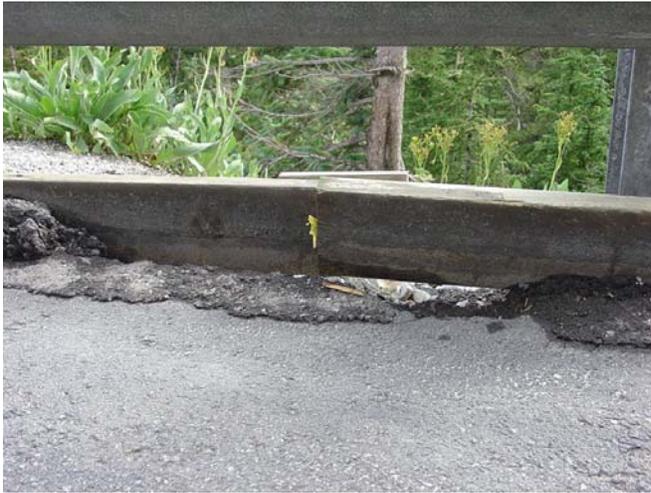
split, crack, twist and warp (**Figure 3**). That tendency is what led CDOT to try new curb materials.

**Figure 3. Wood curb can twist and warp.**

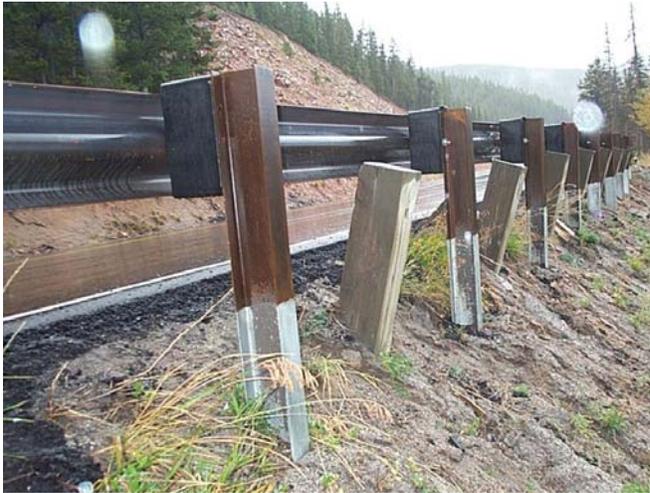
**Figure 4. US-50 has steep slopes to both sides.**

Much of the highway is cut into the side of the mountain with steep slopes above and below (**Figure 4**). About 2,000 feet of DFC and nearly 7,000 feet of composite curb was installed on the project. Annual average daily traffic is 2,300 with 20.1% trucks.

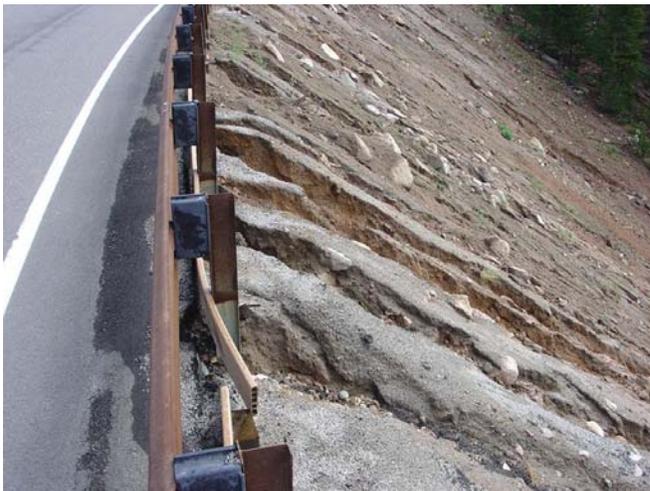
Most of eastbound US-50 at the site has guardrail on the right shoulder protecting high, steep embankments. In some areas the guardrail sits just outside the highway shoulder stripe. The area experiences heavy snowfall in the winter and sudden, intense rain storms in the summer. Both melting snow and heavy rain contribute to periods of heavy, fast-moving runoff that, if not controlled, can do extensive damage in a very short time. To make matters worse, the sparsely-vegetated and very steep sandy-gravel embankments (**Figure 5**) are highly susceptible to very rapid erosion. And in many places, they begin right at the edge of the pavement.

**Figure 5. Severe erosion can occur very rapidly.**

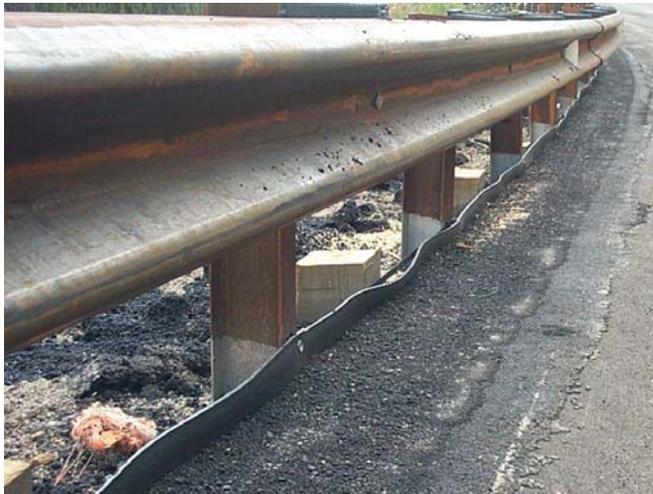
**Figure 6. The edge of the pavement was placed and compacted by hand.**

Unfortunately, having the block-outs and guardrail already in place prevented the paver and rollers from operating close to the guardrail posts, so the asphalt for about two feet out in front of the curb had to be placed and compacted by hand (**Figure 6**). This resulted in lower density, hence, lower strength in the mat next to the curb.

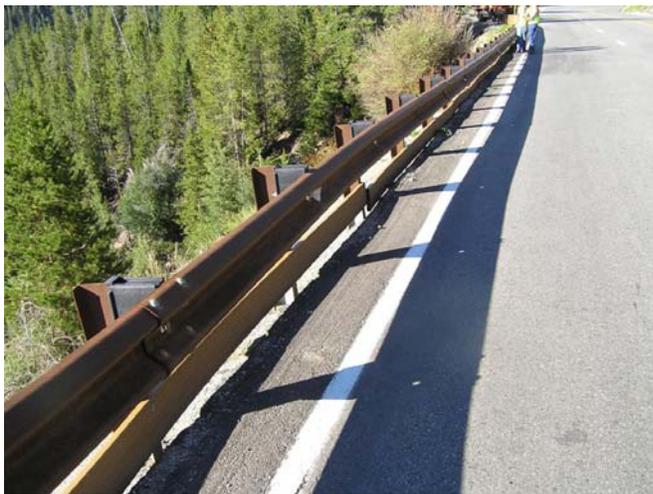
**Figure 7. Slight movement of the guardrail can render the curb completely ineffective.**

If a watertight condition can be maintained at the pavement/curb joint, any curb can be effective. However, it is virtually impossible to maintain a watertight joint over long periods with curbing material that relies on the guardrail posts for support. Any impact on the guardrail is likely to move one or more posts, and with them the curb, breaking the seal between the curb and the pavement surface.

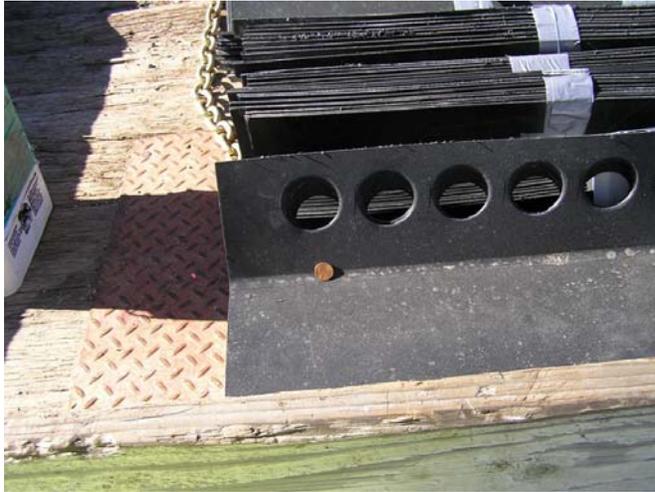
**Figure 8. Holes in the horizontal leg of the DFC help the layers of asphalt bond together to strengthen the curb.**

As **Figure 8** shows on the previous page, the HDPE had a memory; it tried to return to its original flat shape rather than maintain a 90° bend. Because the curb material had partially flattened out, it was difficult for the installers to push it tight against both the bottoms of the guardrail posts and the surface of the asphalt at the same time. They used shovels to hold the curb in place while it was nailed to the pavement along the edge of the horizontal leg (**Figure 10**). (The DFC was not nailed to the guardrail posts on US-24.)

The problem was partially solved by using additional nails near the angle. However, the solution was only partially effective; as

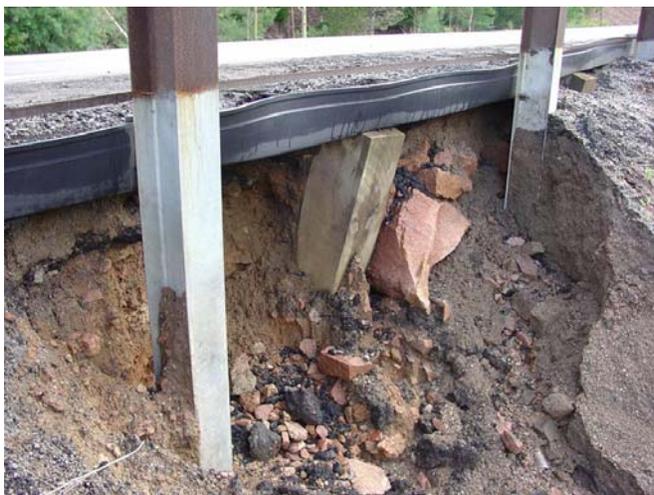
**Figure 9. Without the support of the DFC, the edge of the pavement would have collapsed.**

By virtue of its L-shape and overlap of the sections, DFC provides a continuous water-flow channel. In fact, the curb can even serve as reinforcement and support the edge of the pavement under some circumstances. **Figure 9** shows an area washed out behind the DFC. Apparently a high volume of water during a very heavy rain overflowed the curb and cut the base out from under the edge of the pavement.

water between the HDPE and the pavement. DFC's strength shown in **Figure 9** is also a potential weakness: Where the curb is embedded in the pavement it may provide a weakened plane and an access path for moisture to get into the pavement. Its efficiency practically guarantees the presence of some moisture all along the curb. In cold mountain locations, freeze-thaw cycles will almost certainly lead to failure if any moisture penetrates the pavement.

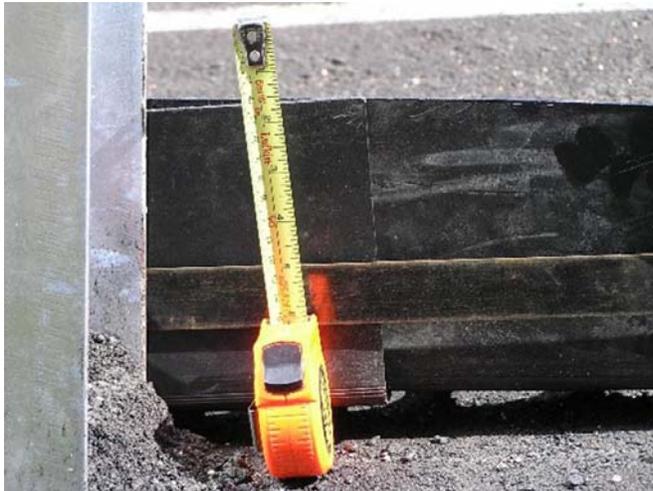
the curb continued to try to flatten out, it actually pulled many of the four-inch nails out of the asphalt. As **Figure 11** shows, the base of the curb was not tight against the pavement in many places. This was partly due to movement in the curb as described, and was partly due to the

**Figure 11. Air gaps between the curb material and the pavement surface.**

uneven surface below the curb. In any case, the gap causes a weak place in the pavement, and provides a path for water penetration.

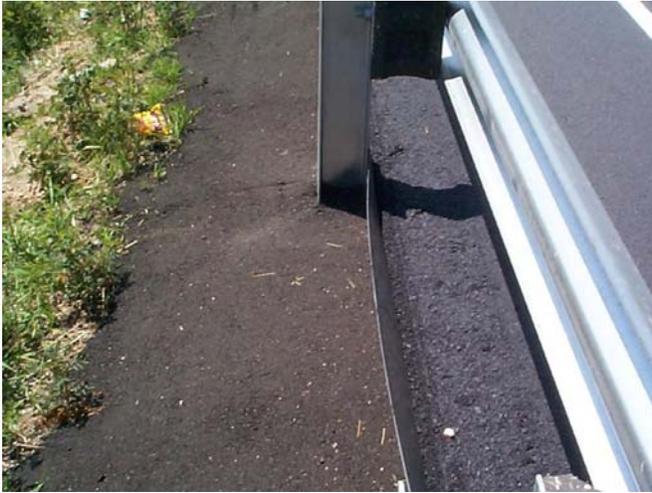
Another problem caused by the curb's memory resulted in bows in the vertical curb face between the guardrail posts. Heat and pressure from the final lift of asphalt on the face of the curb aggravated the effect. This condition, shown in **Figure 12**, was primarily a cosmetic problem. However, if it became too extreme, it would effectively lower the curb's height and reduce its water carrying capacity.

**Figure 12. Wavy curb face between guardrail posts is mainly a cosmetic problem.**

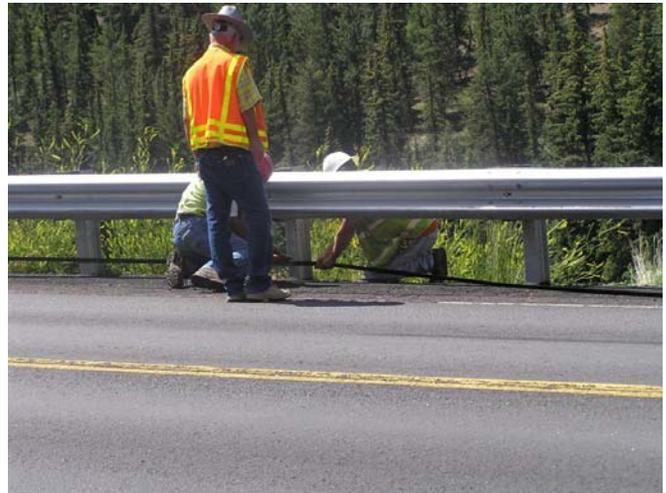
**Figure 13. Steel band was installed to provide support for the DFC between posts.**

as shown in **Figure 13**. While the band was not completely successful in eliminating the bows, it did provide some support for the vertical face of the curb.

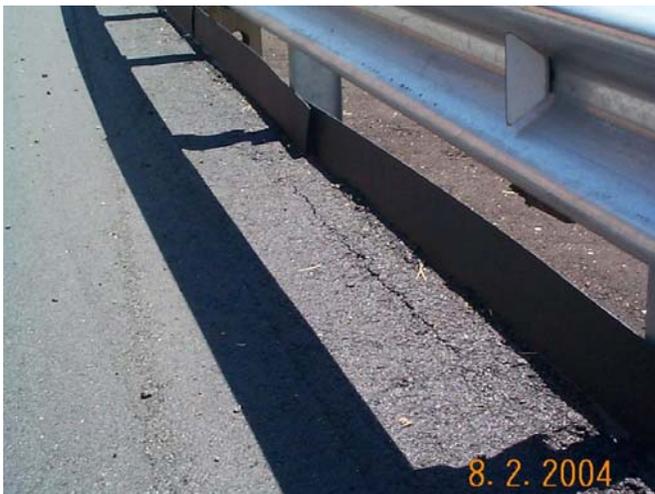
**Figure 14. Cracks along the edge of the HDPE on US-24.**

manufacturer thought the high temperature of the hot mix would soften the HDPE and allow the asphalt to bond to it, effectively making the curb a part of the pavement. However, a short time after construction, evidence of cracking along the edge of the embedded curb seemed to indicate that the bond between the curb and the asphalt did not develop. **Figure 14** shows a developing crack on US-24, **Figure 15** shows similar cracks at the end of a DFC section on US-50.

**Figures 14 and 15**, above, show cracks in the asphalt along the edge of the curb's horizontal leg. It appears that the HDPE promotes weakness in the asphalt which resulted in the pavement beginning to delaminate. Apparently, the asphalt did not bond to the curb, and there was not enough adhesion through the holes in the curb to prevent the top lift from separating. It is also likely that reduced density of the hand placed and compacted asphalt contributed to weakening the pavement in the area.

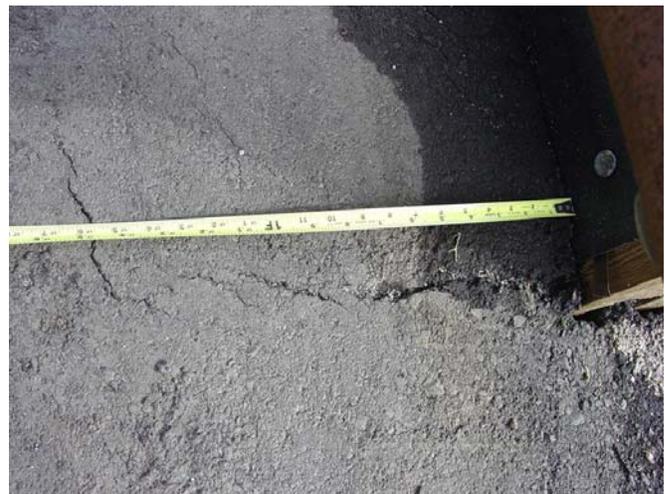
**Figure 15. Cracks are developing at the end and along the edge of the DFC on US-50.**

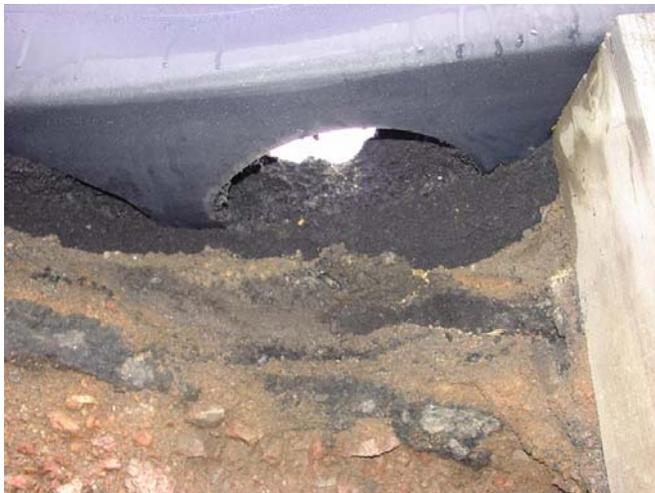
This picture, **Figure 18**, is a close-up of the damage shown in **Figure 9** above. It shows a section of DFC supporting the edge of the pavement after runoff washed a large hole under it.

The wood post in **Figure 9** is at the right edge of this picture. When the shoulder eroded away, the asphalt from below the DFC also washed out, and took the top lift from above the hole with it. If the asphalt in this area had been properly compacted it would probably have been able to carry its own weight and would not have been carried away by the water.

**Figure 18. Close-up of the washout in Figure 9.**

From a maintenance viewpoint, one of the main drawbacks of DFC is difficulty of repair if a curb section must be replaced. Removal of a damaged section, without causing significant damage to the pavement and to the adjacent sections of curb, is difficult. Repairs that require replacement of a curb section will often be the result of damage to the pavement or severe damage to the base. At the location in **Figure 18**, a significant amount of the base material will require replacement. Without removing at least one section of curb there is no way to place and properly compact material to fill the void below the pavement. The fill must be well compacted; it is also very important that the new base be carefully graded so it can properly support the new section of DFC and asphalt.

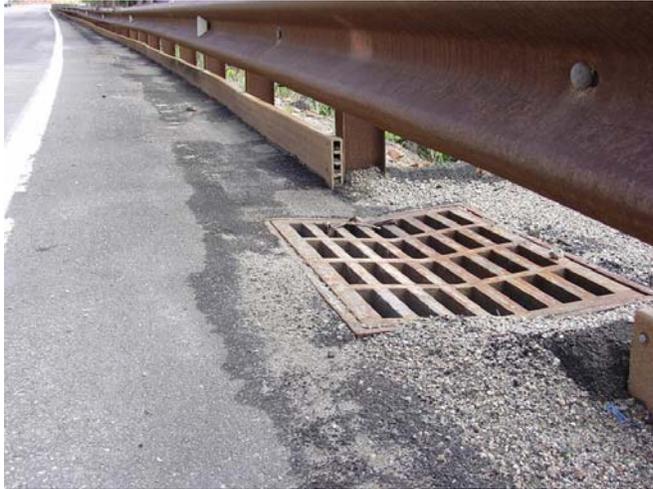
**Figure 19. A hollow section of composite lumber curb ends at a drain.**

The composite curb used on Monarch Pass was a hollow 2 x 8 with four cross webs as shown in **Figure 19**. Probably as a result of its hollow nature, the material had deformation problems, a low resistance to buckling and was fairly easily broken. Solid material may have performed better.

The hollow cross-section composite lumber material used on US-50 was susceptible to cracking and breaking. Solid lumber may be more durable and better suited for use as highway curb.

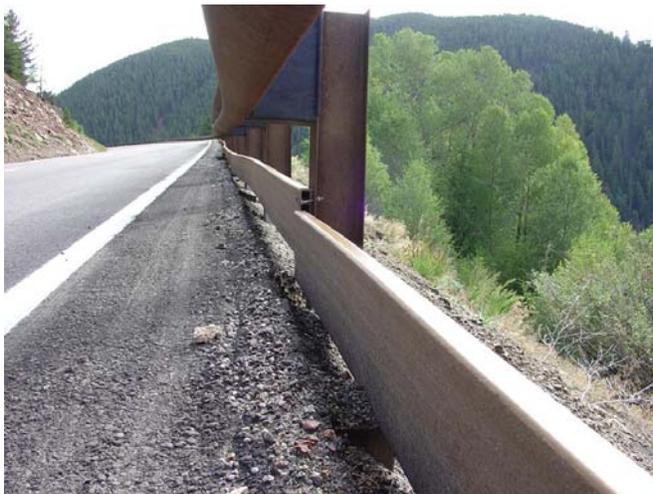
**Figure 20. A small movement of the guardrail separated this curb from the pavement.**

Composite lumber curb is totally dependent on the guardrail posts for support and positioning. Any movement of the guardrail will open a gap between the curb and the pavement allowing water to erode the shoulder. Sections of curb are easily replaced, however, if the damage was the result of movement of the guardrail posts, the curb will no longer fit tightly against the pavement and the gap will have to be filled. Hand construction of a berm against the face of the curb works well for smaller gaps, and may be advisable as a preventative measure.

Generally, if the curb is damaged, repairs consist of removing the damaged section of lumber, installing a new piece, backfilling any lost base material and patch paving in front of the curb. If the problem is due to the curb being separated from the pavement but not damaged, as happened in **Figure 20**, repairs usually consist of patching the separated area with asphalt. (Crack sealing materials were tried on small breaches between the curb and pavement, but none performed well.) This type of repair led maintenance personnel to form a small berm against the face of the curb using asphalt patching material. The curb

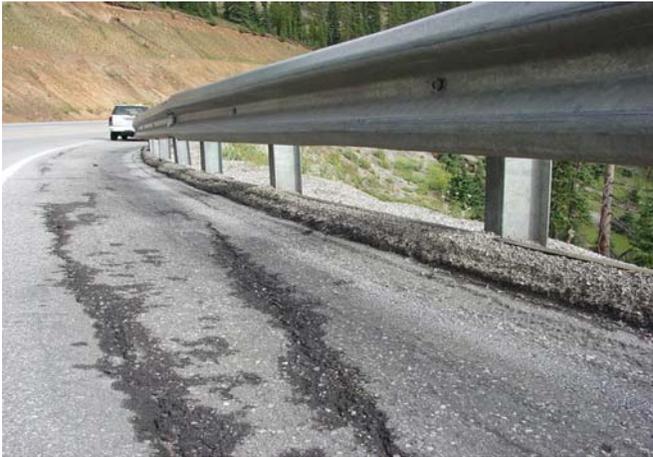
**Figure 21. An asphalt berm in front of a wood curb.**

moved. This technique results in a curb similar to a slip formed asphalt curb and, although not as durable, it is much cheaper. **Figure 21** shows an asphalt berm in front of a lumber curb. In locations where the guardrail is repeatedly subjected to small movements, this preventive maintenance treatment can be effective in reducing the repairs needed by the shoulder behind the curb.

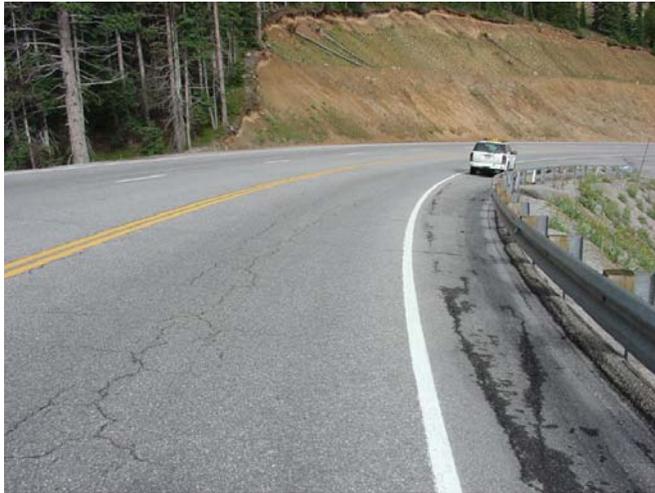
**Figure 22. Wide highway and steep shoulders.**

- US-50 on the west side of the pass is a two-lane highway with wide lanes and several passing zones. Its large surface area (**Figure 22**) collects a significant amount of water from rain and melting snow, and the grade and slope of the pavement give considerable velocity and force to the runoff. The water volume that the pavement gathers can overwhelm the curbs, which have an effective height of only four to six inches, with disastrous results – see **Figure 9**, above.

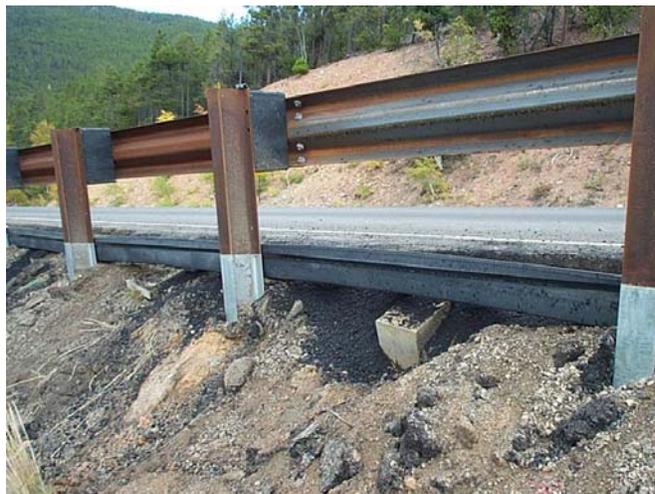
**Figure 23. Slopes start under the guardrail.**

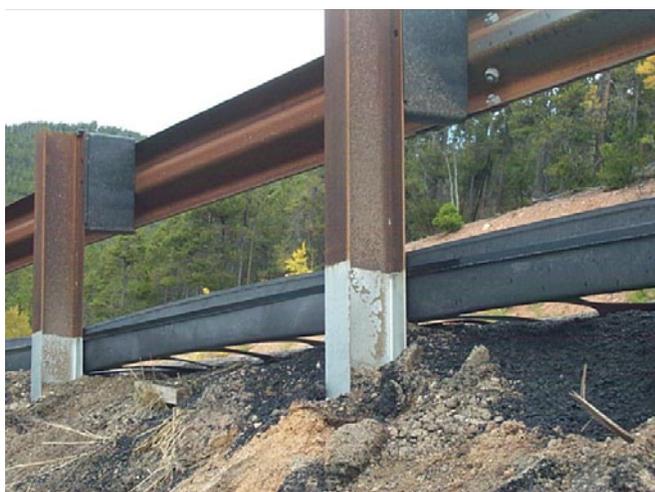
**Figure 24. Inadequate base for the DFC.**
