**Report No. CDOT-2007-3  
Final Report**

# **DURAFLEX CURB**

**COLORADO DEPARTMENT OF TRANSPORTATION  
RESEARCH BRANCH**

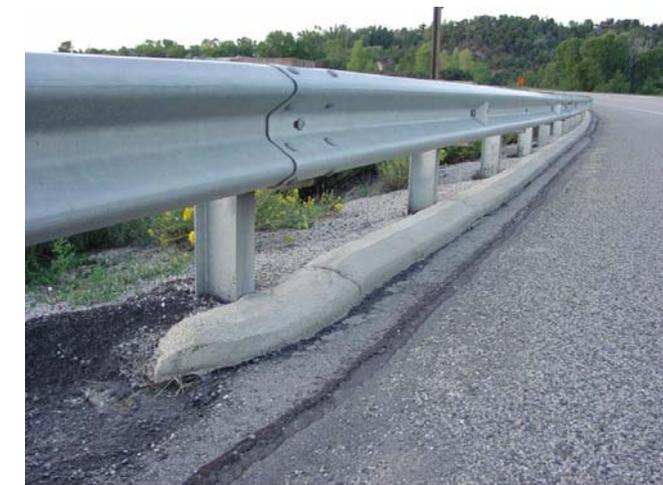
In the past, most of Colorado’s rural highway curbs were either extruded from pavement material or pressure treated lumber. Extruded curbs can be made by passing concrete or asphalt through specially designed slip form machines. Extruded curbs (**Figure 2**) are very

**Figure 2. Extruded curb - concrete in this case.**

effective, and are not easily damaged by traffic or normal maintenance operations such as snow removal. However, they are expensive. Repairs are difficult and installation of new extruded curb as part of an overlay project is very difficult if guardrail is already in place, because the machinery cannot operate below existing guardrail.

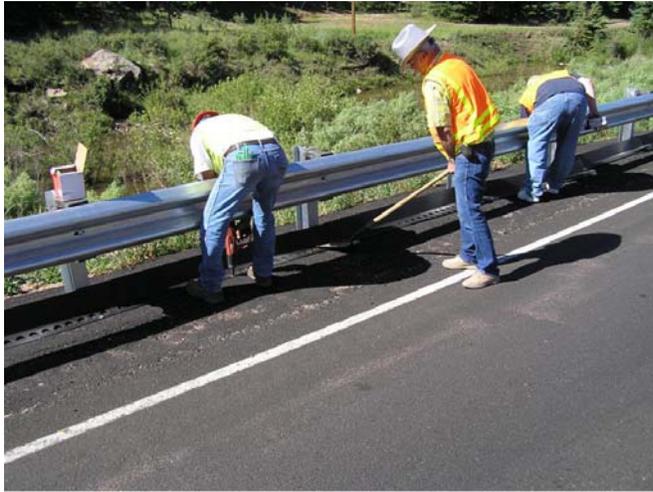
**Figure 10. Holding DFC tight against the post base and the pavement with a shovel.**

As **Figure 8** shows on the previous page, the HDPE had a memory; it tried to return to its original flat shape rather than maintain a 90° bend. Because the curb material had partially flattened out, it was difficult for the installers to push it tight against both the bottoms of the guardrail posts and the surface of the asphalt at the same time. They used shovels to hold the curb in place while it was nailed to the pavement along the edge of the horizontal leg (**Figure 10**). (The DFC was not nailed to the guardrail posts on US-24.)

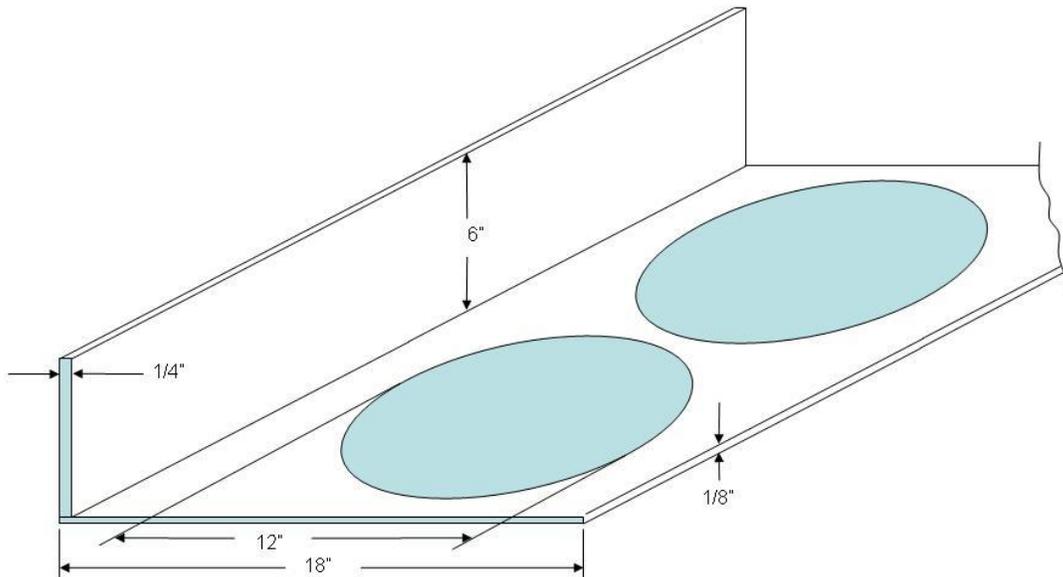
Before the Monarch Pass project, the DuraFlex Curb was extensively redesigned. The new curb is extruded with the 90° L-shape rather than a formed sheet. The curb has a 6-inch vertical leg – doubled in thickness to 1/4 inch, and is anchored into the asphalt by an 18-inch horizontal leg.

**Figure 16. Drawing of the modified DuraFlex Curb used on US-50.**

The horizontal leg is 1/8 inch thick and has a row of 12 inch diameter holes spaced one inch apart along its length. When the asphalt is laid over the curb, the larger diameter the holes provide more area to improve the bond between the asphalt lifts and help make the curb become a part of the pavement. The curb sections are light and easy to transport and handle - the entire quantity of ±2000 feet for the project was delivered on a 15 foot goose neck trailer.

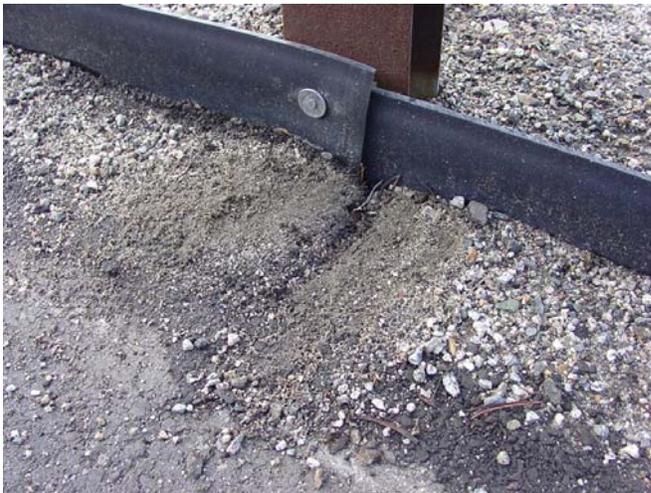
**Figure 17. DFC nailed to a guardrail post on US-50.**

the downhill one. For the Monarch project, the curb was nailed to the guardrail posts near the top of the curb (**Figure 17**).

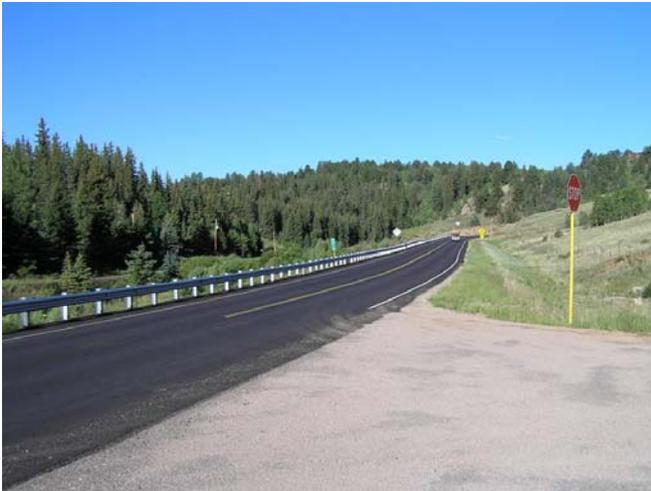
**Figure 25. US-24 on Ute Pass.**

roadway. US-24 near Divide **Figure 25** is such a location: a narrow, gently sloping, two-lane road, crowned in the center, with gently sloping shoulders. Water carried by the curb in this kind of location will have little energy to cause problems even if it does find a gap in the curb.

Satisfactory performance can probably be expected in locations where the consequences of a break or overflow are not likely to very rapidly lead to severe structural problems for the
